Rainier Commons Work Plan

Exterior Paint Removal & Limited Scope for Follow-up on Interior Surfaces

**Dated March 25, 2013
Revised July 25, 2013**

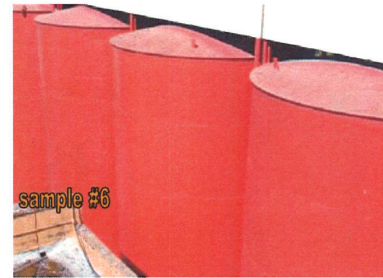
East elevation

Silo height – 36'
4 – 15' Diameter Tanks
5500 Cubic Feet
